AL ALWAIYA CHILDREN'S HOSPITAL  
BAGHDAD, IRAQ

**SIGIR PA-06-065**  
**JANUARY 10, 2007**

SUBJECT: Report on Project Assessment of the Al Alwaiya Children's Hospital,  
Baghdad, Iraq (Report Number SIGIR-PA-06-065)

## Al Alwaiya Children's Hospital, Baghdad, Iraq

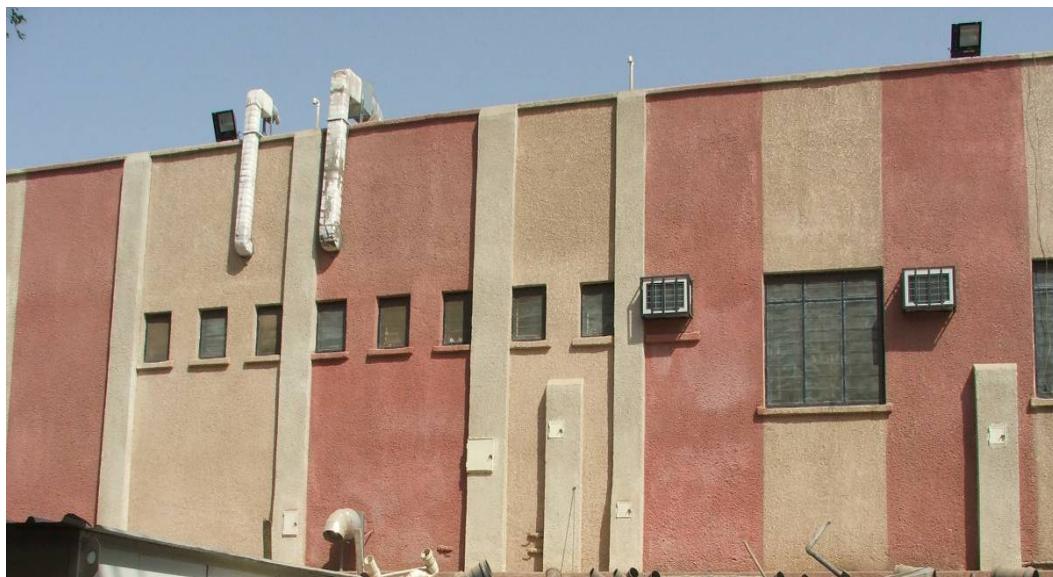
Site Photo 1. Exterior of building B2

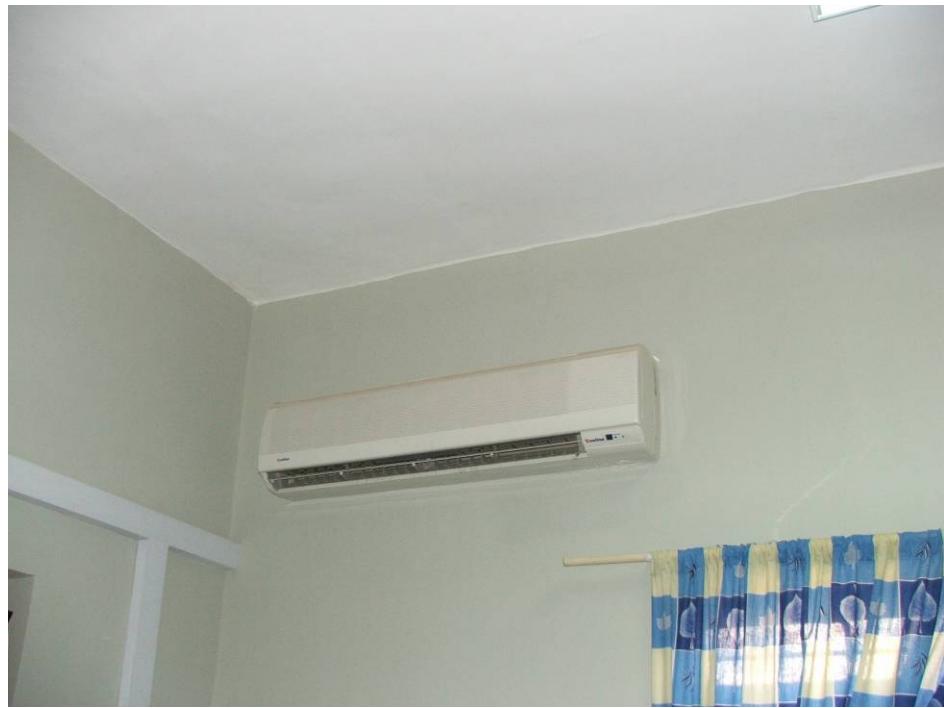
**Site Photo 3. Split system HVAC evaporator unit in building B2**

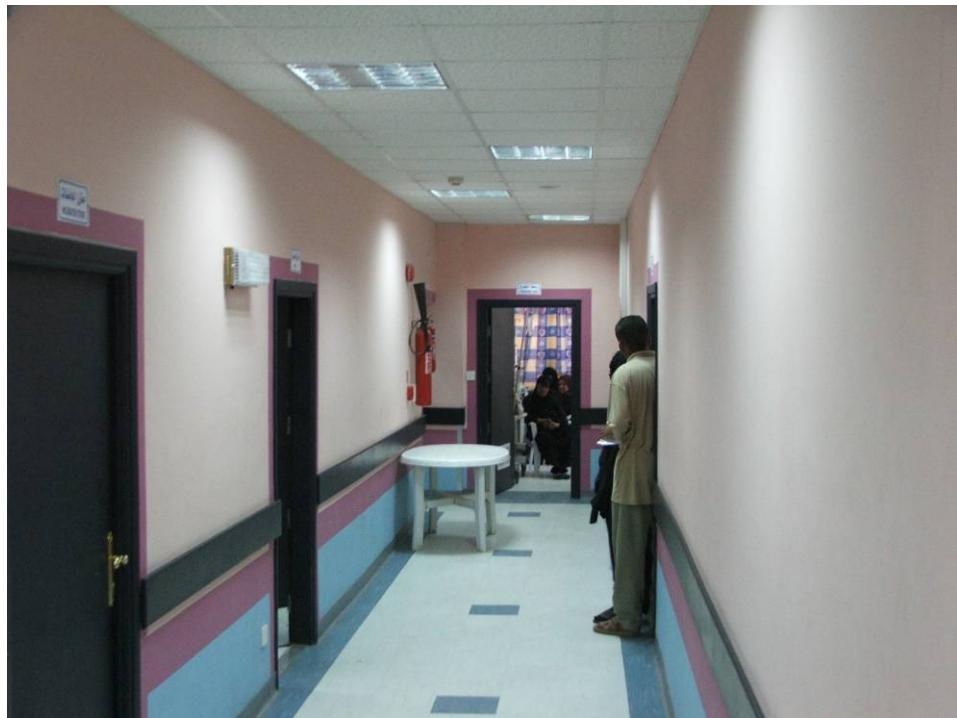
**Site Photo 4. One of the main corridors in building B2**

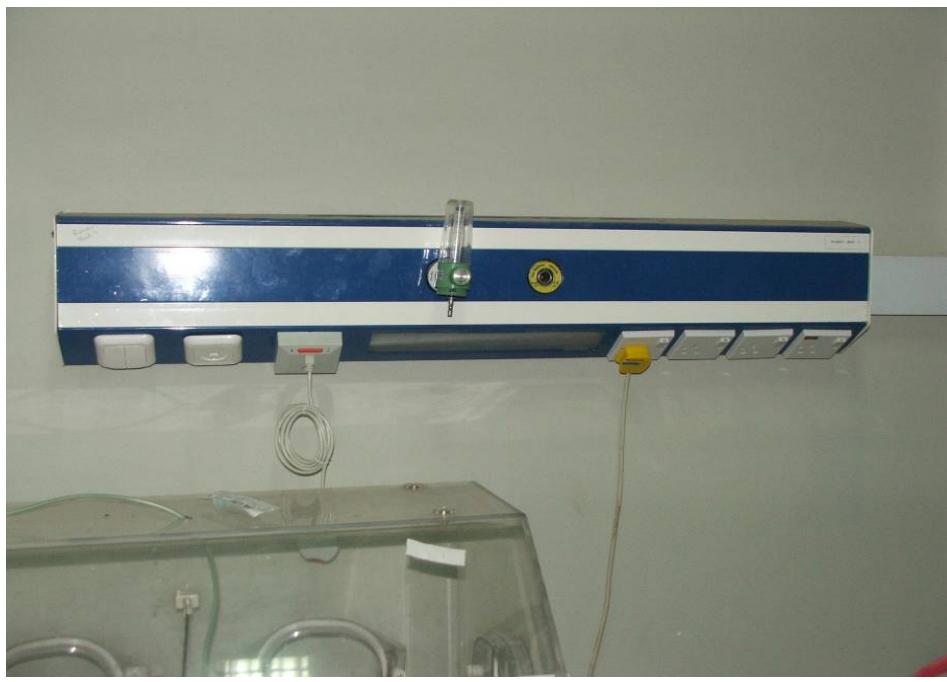
**Site Photo 5. Electrical outlet box in patient ward in building B2**

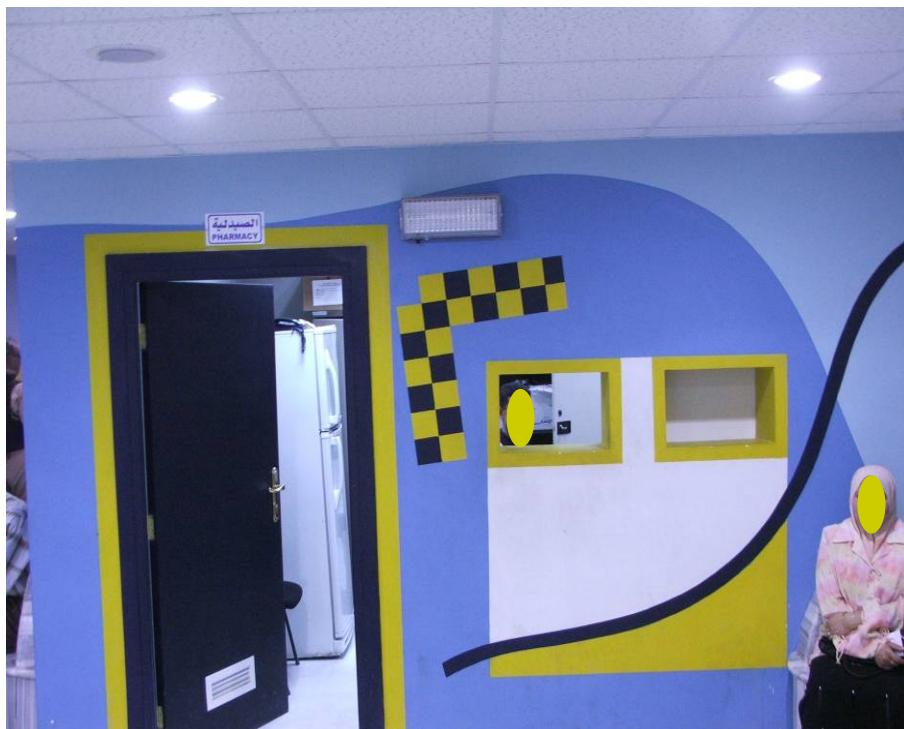
**Site Photo 6. Pharmacy in the outpatient clinic**

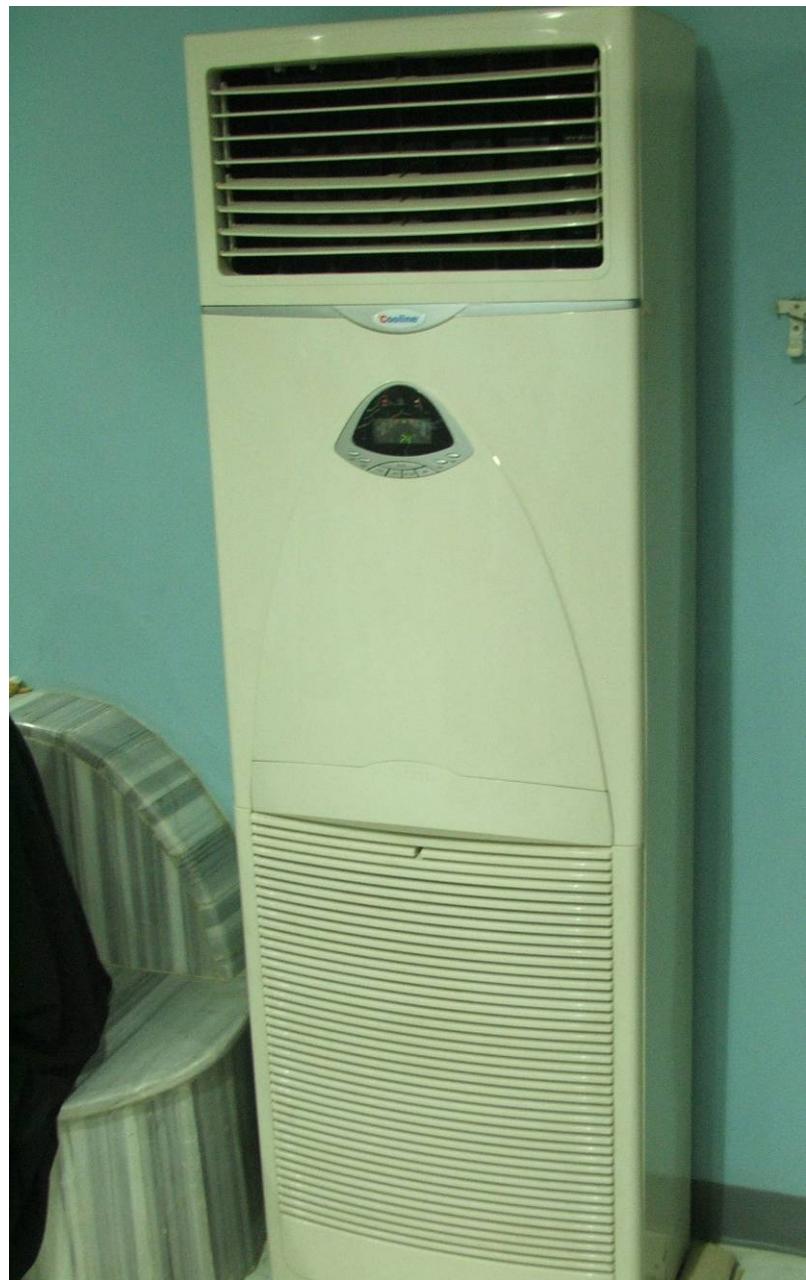
**Site Photo 7. Stand alone HVAC unit in the clinic waiting area**

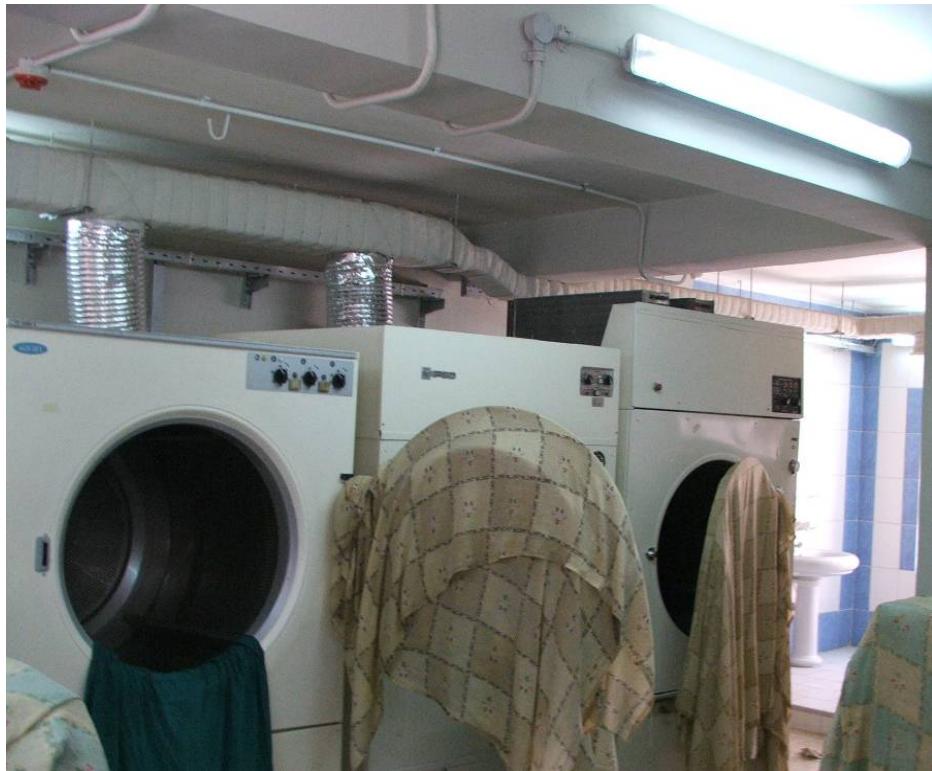
**Site Photo 9. Laundry room containing dryers**

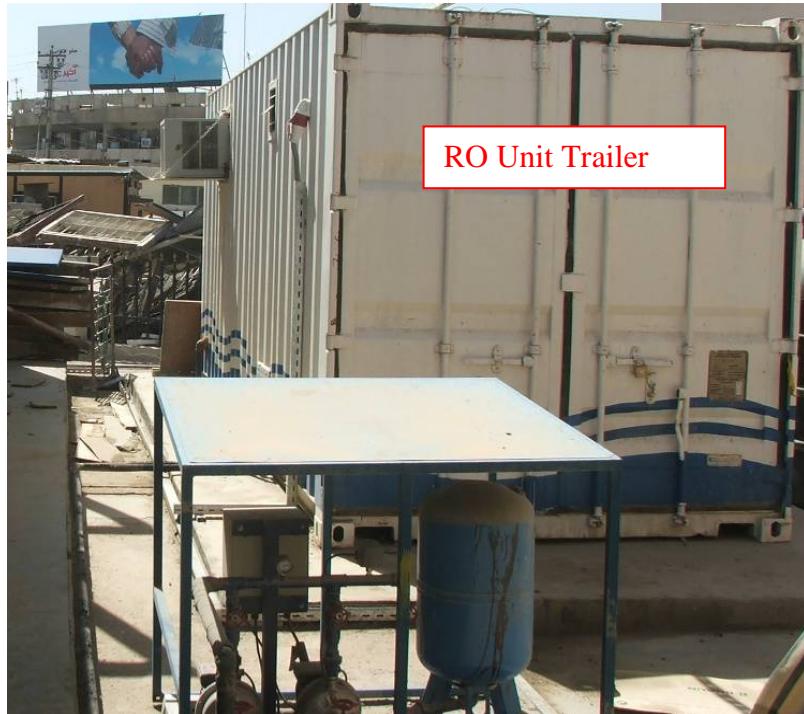
**Site Photo10. Container housing the RO unit**

During our site visit, we observed the components for the RO unit in-place inside the trailer. The USACE DRE and PE told us the RO unit was not functioning or being utilized by the hospital staff. The USACE DRE also believed the RO unit's semi-permeable membranes were plugged by a bio-film residue covering the membrane pores, since the RO unit was not operating and backwashing on a continuous basis. Site Photo 11 shows pressure vessels containing the semi-permeable membranes and Site Photo 12 shows the control panel for the RO unit.

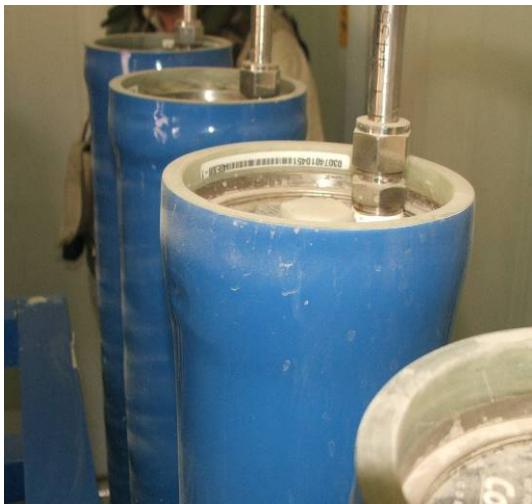
**Site Photo 11. Pressure vessels containing RO membranes**

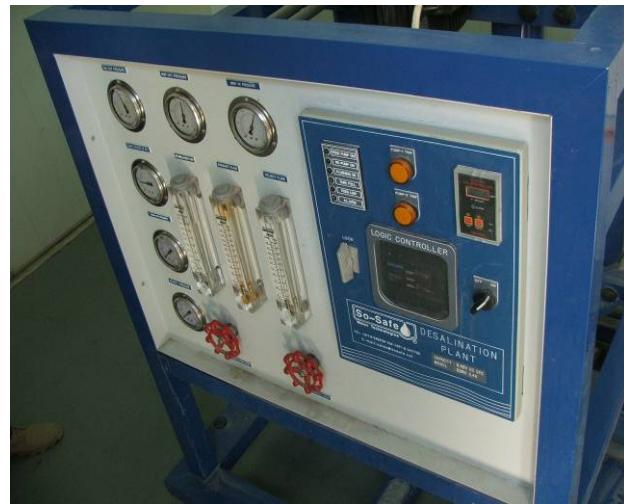
**Site Photo 12. RO control panel**

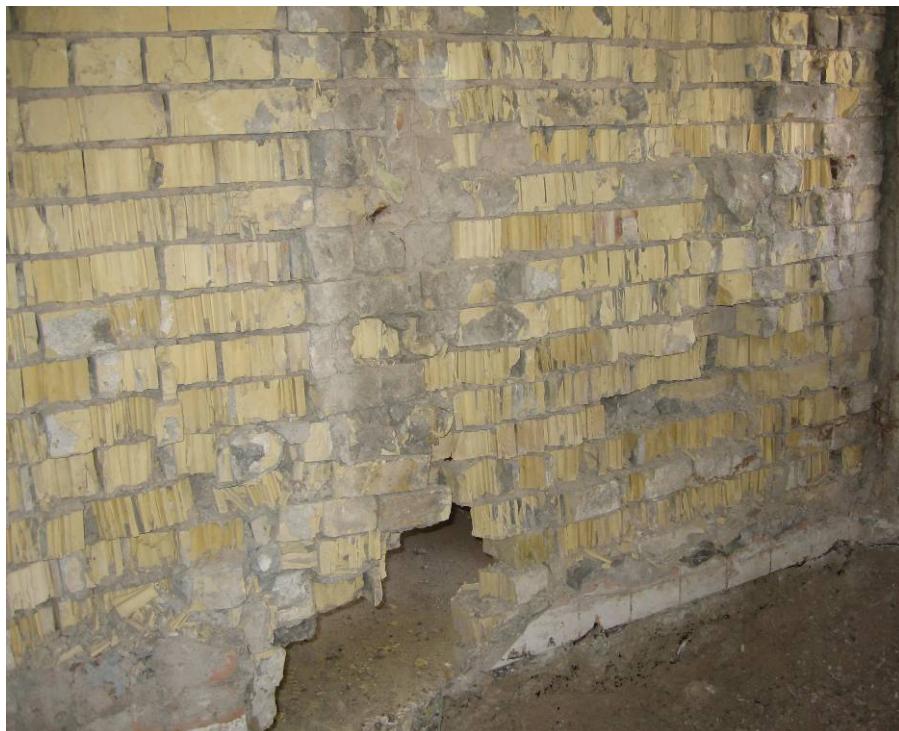
In our inspection of these two buildings, no significant discrepancies were found. However, in some areas, it appeared the existing brick walls and lintels had been poorly constructed when the buildings were originally constructed. Site Photo 13 provides an example of one of the original brick walls requiring repair or replacement. Further, some of the exposed lintels had only been supported on one side of the doorway, as shown in Site Photo 14. According to the USACE, the renovation work would include proper support for the lintels.

**Site Photo 13. Existing brick walls in building B1 after demolition of interior finishes**

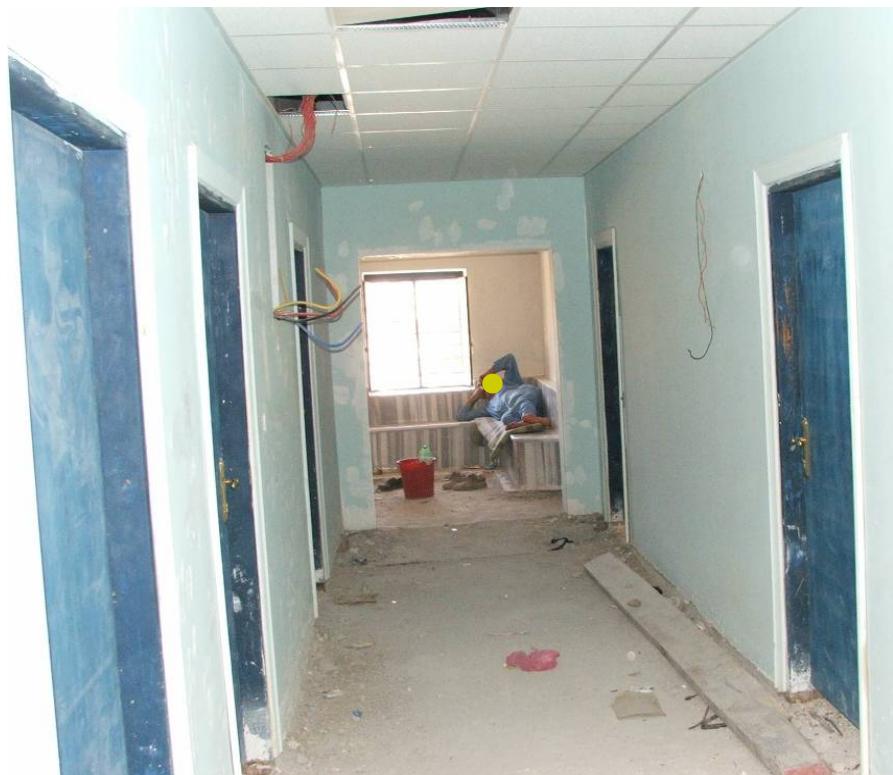
The contractor had also installed electrical conduit and pulled wire in the rear section of building B1. In addition, we also observed bathrooms where the contractor had placed new ceramic tile on the floors and walls. Site Photo 15 shows one of the corridors in the rear section of the building after the walls had been repaired, plastered and painted. Site Photo 16 shows the completed ceramic tile installation and a new wash basin in one of the bathrooms on the first floor. In this section of building B1, we did not observe any noticeable deficiencies in the workmanship.

**Site Photo 15.** Plastered and painted walls in the rear section of building B1.
